Accident Investigation: Electrical Accident May 22, 2001

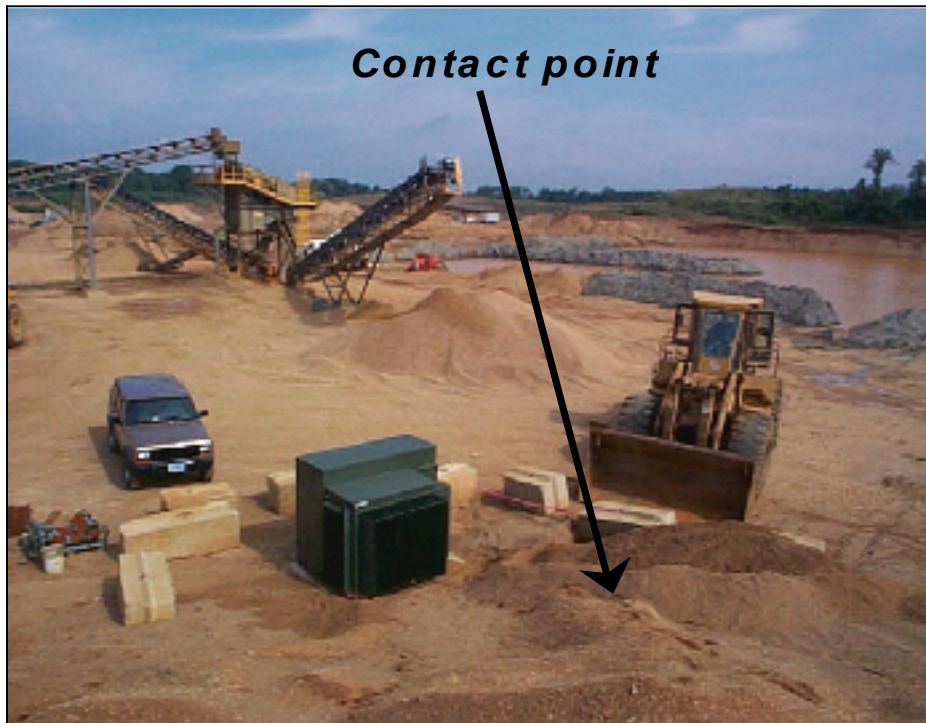
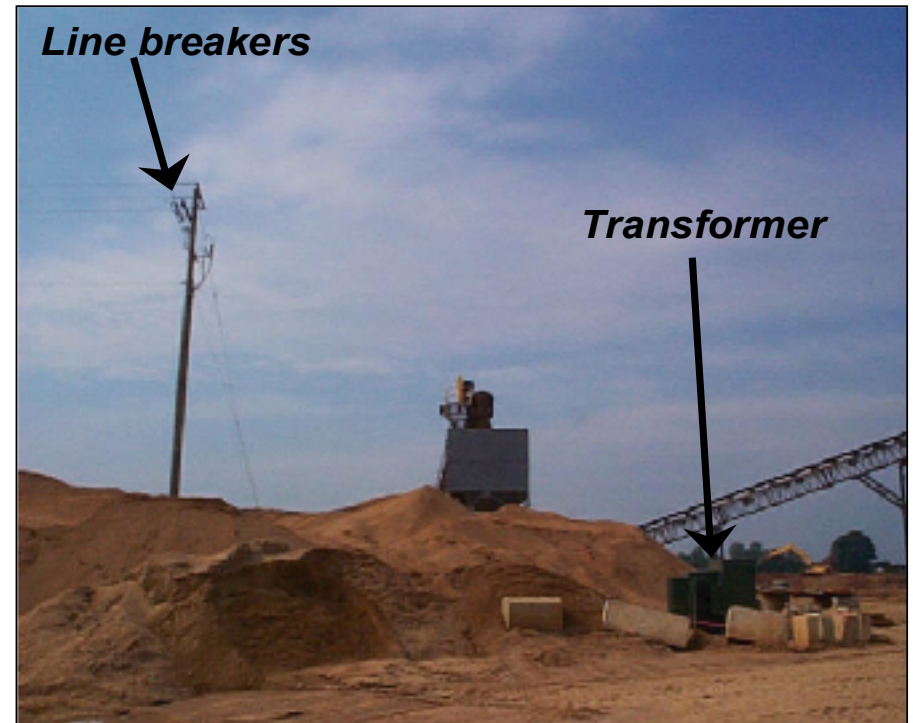
A mine worker operating a front-end loader struck and cut buried high voltage (34,000 volts) power lines feeding a totally enclosed transformer located on a concrete pad. The worker was attempting to remove accumulated sand around the barricaded transformer prior to thunderstorms forecast for the region. The bucket of the front-end loader struck and cut the buried wires which then tripped the breakers on a nearby power line pole. Luckily, the worker was not injured.

RECOMMENDATION: Always contact "Miss Utility" to identify and mark location of buried utility lines prior to digging by hand or use of mobile equipment; failure to locate and mark buried lines could result in personal injury, penalties, and disruption of plant production/operation.
