## DMM Safety Alert: Customer Fatality

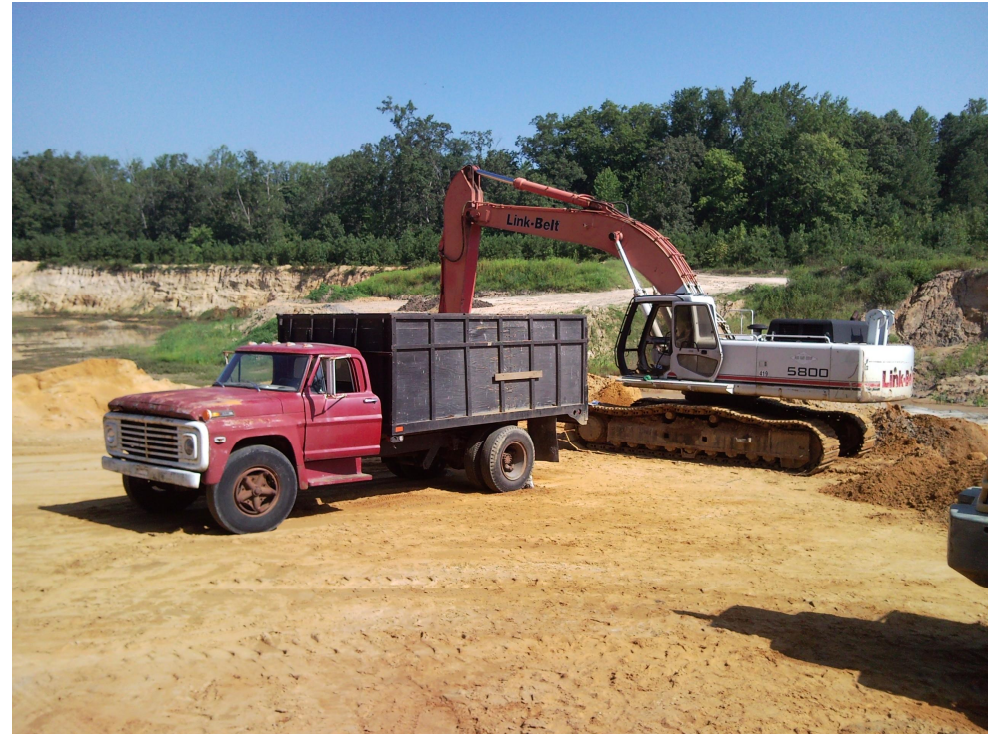
On August 18, 2009, a customer received serious injuries at a sand and gravel mine in Virginia that resulted in his death on August 22, 2009. The customer, a local farmer, drove his single axle dump truck to an area of the mine to be loaded. After stopping his truck, he got out and went to speak with the excavator operator who was to do the loading. While the customer was speaking to the excavator operator, the truck rolled backwards striking and pinning the victim between the back of the truck and the side of the excavator. Local EMS personnel were summoned and the injured man was air lifted to a hospital where he succumbed to his injuries four days later. To help ensure customer safety on mine sites and avoid a similar type of accident from occurring, the Virginia Division of Mineral Mining recommends the following:

Victim was pinned between the back of his truck and the side of the excavator.

- Customers/truck drivers must be instructed regarding the hazards they may encounter while on the mine site, such as:
  - Persons on the ground must not position themselves in such a way as to be endangered by the movement of mobile equipment (**4VAC25-40-1600**).
  - Mobile equipment must not be left unattended unless the brakes are set. If on a grade, the wheels must be blocked or turned into a bank (**4VAC25-40-1510**).
  - Eye contact must be made with equipment operators prior to approaching, mounting or dismounting equipment (**4VAC25-40-1560**).
- In the vast majority of cases, it is best to require drivers to remain in their truck cabs at all times while in the loading area.
- Clear loading instructions should be posted and explained to all drivers.
