DMM Safety Alert: **Blocking Stationary Equipment**

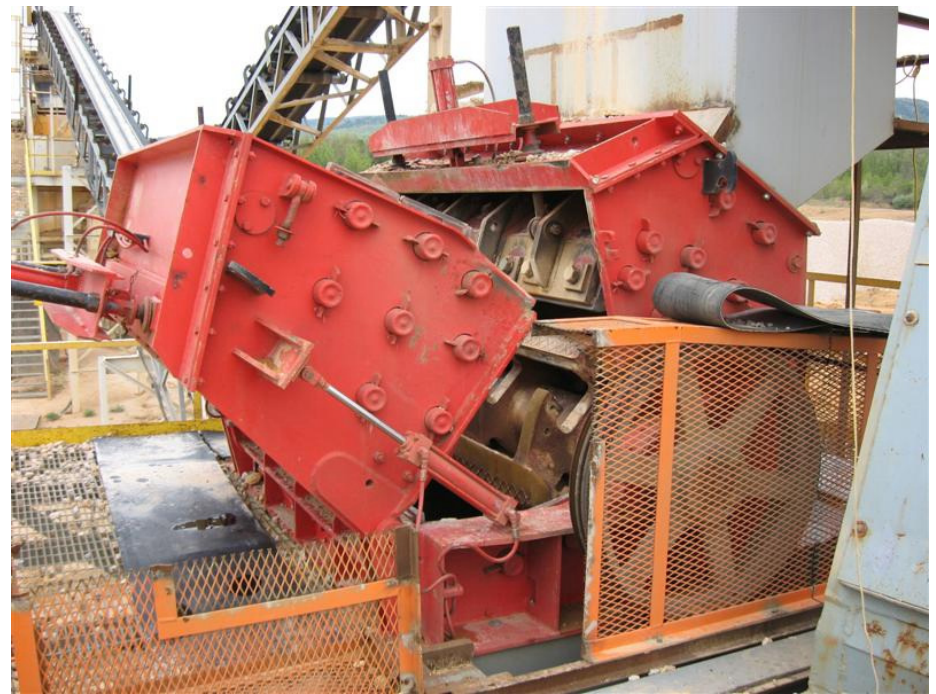
In May 2007, a Virginia miner was seriously injured when his chest was crushed between the blow bars and the housing of the impact crusher he was working on. The miner had just released a safety pin that kept the bars from rotating, when the unbalanced hammer unit rotated, pulling him into the crusher. The miner broke two ribs and suffered internal injuries. Over the past years, other miners have been seriously injured when parts of de-energized equipment moved due to gravity or other sources of stored energy. The Division of Mineral Mining safety regulations require miners to block stationary equipment prior to the start of repairs or maintenance. To avoid injury, safe work practices should be followed, including:

Impact crusher involved in accident

- Prior to starting work, assess potential safety and health hazards and determine the appropriate work procedures and personal protection equipment to be used.
- If equipment is electrically powered, de-energize, lock out and tag out the source of power (4VAC25-40-2140).
- Block the equipment against motion, except where motion is necessary to make adjustments. De-energize or isolate other energy sources such as stored electrical energy, hydraulic pressure, air pressure or gravity (4VAC25-40-350).
- Operate and maintain equipment in accordance with the manufacturer's specifications and operating instructions (4VAC25-40-360).

Always consider the potential hazards related to the sudden movement of equipment parts due to gravity or other stored energy when performing maintenance or repairs.
