DMM Safety Alert: Impoundment/Dam Failures

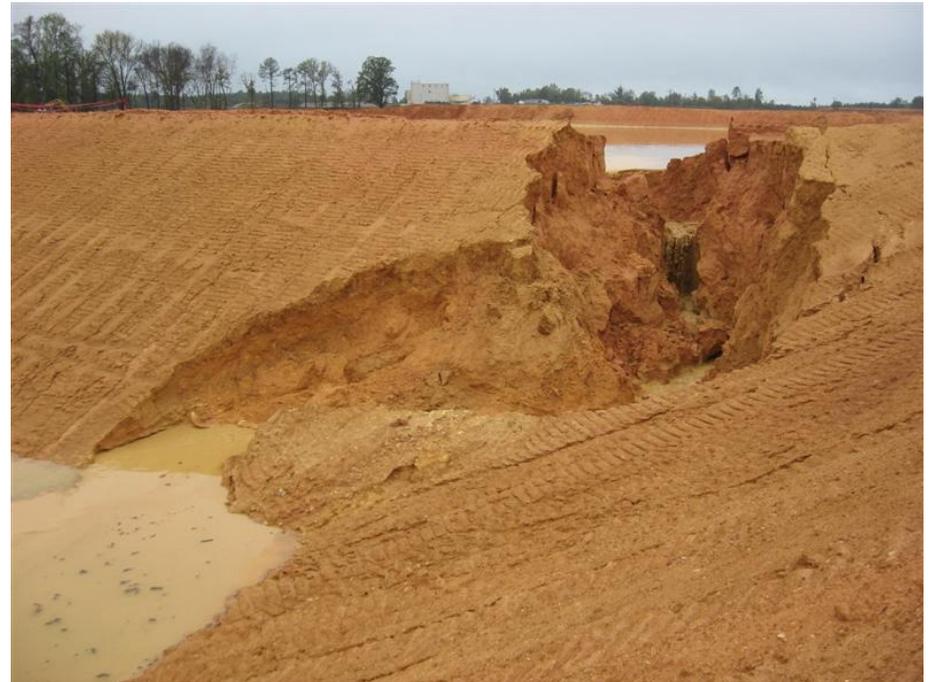
Many of the mineral mines in Virginia utilize ponds/impoundments as a part of their operations. In October 2007, the embankment of a tailings pond failed at a sand operation that uses many of these ponds to control and retain tailings. The failure most likely occurred due to “piping” through a tension crack in the crest of the embankment. A contractor employee working nearby noticed seepage through the embankment and alerted other personnel in the area. Within five minutes, a hole two feet in diameter had developed in the dam approximately two feet below the crest. This steadily increased in size until the crest collapsed about forty-five minutes later leaving a gully twelve to fifteen feet wide (see photo below). Fortunately, no one was injured and there were no off-site effects or damage.

DMM reminds mine operators that impoundments must be constructed, operated and maintained in accordance with 4VAC25-31-500 of the Mineral Mine Reclamation Regulations of Virginia. Specific requirements for small ponds, as described in 4VAC25-31-500.B, include:

- Ponds must be designed and constructed using current, prudent engineering practices to safely perform the intended function.
- Slopes must not be steeper than two-to-one in predominantly clay soils or three-to-one in predominantly sandy soils.
- Temporary pond structures must be able to safely pass the runoff from a fifty-year storm event.
- Adequate protection must be provided for adjacent property owners and ensure public safety.
- Structures must be inspected and maintained to ensure proper functioning.
- ❖ All water and silt retaining dams must comply with chapter 18.1 of the Mineral Mine Safety Laws Of Virginia.
