DMM Safety Alert: Miners Working Alone

The Virginia Division of Mineral Mining (DMM) is highlighting a fatality that took place in the state of Montana due to its pertinence to the many small mine operators here in Virginia. The federal Mine Safety and Health Administration (MSHA) recently released the accident investigation of this fatality that took place on August 2, 2014.

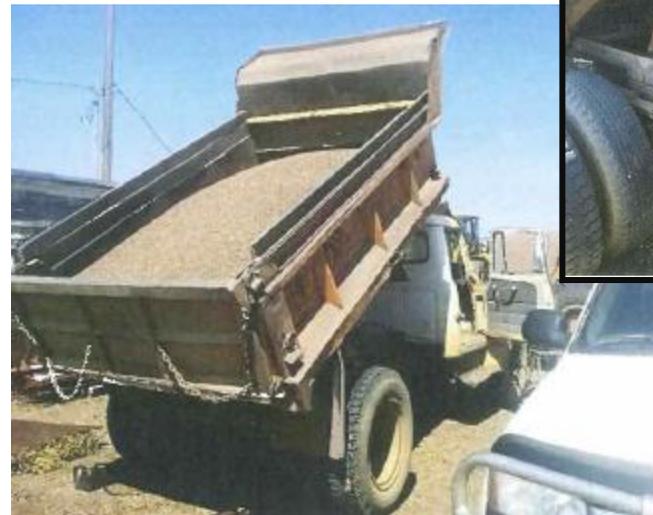
A 53 year-old foreman with 25 years of mining experience was fatally injured at a sand and gravel processing site while working under the raised bed of a dump truck. The site employs two people operating a single shift, five days a week. One person habitually performs maintenance on weekends. On the day of the accident, a Saturday, the victim was working alone on the hydraulic lift system of a dump truck. He had placed a wooden block between the raised body and the frame rail in an attempt to hold the body in position. The miner was under the bed adding hydraulic oil to the system when the block failed allowing the bed to fall and pin him. The local coroner determined that the accident took place at approximately 11:00 AM on August 2nd, but the victim was not found until 10:00 AM on August 3rd.

Accident Scene

- Miners must not work alone in a hazardous area unless they can be seen or heard by another person in attendance.
- Repairs or maintenance must not be performed on mobile equipment until it is tagged out, the power off, and blocked against hazardous motion. Blocking materials must be of a type and capacity suitable for the job.
- Miners must receive task training in maintenance tasks that includes the recommendations of the equipment manufacturer.
- Mine operators should have written procedures regarding the lockout/tag out, de-energizing, and blocking of machinery and equipment.
